October 9, 2020

RE: Year 1 Post-Construction Monitoring Report  
Drum Island Marsh Restoration  
Charleston County, South Carolina  
JMT Project Number: 18-03770-001

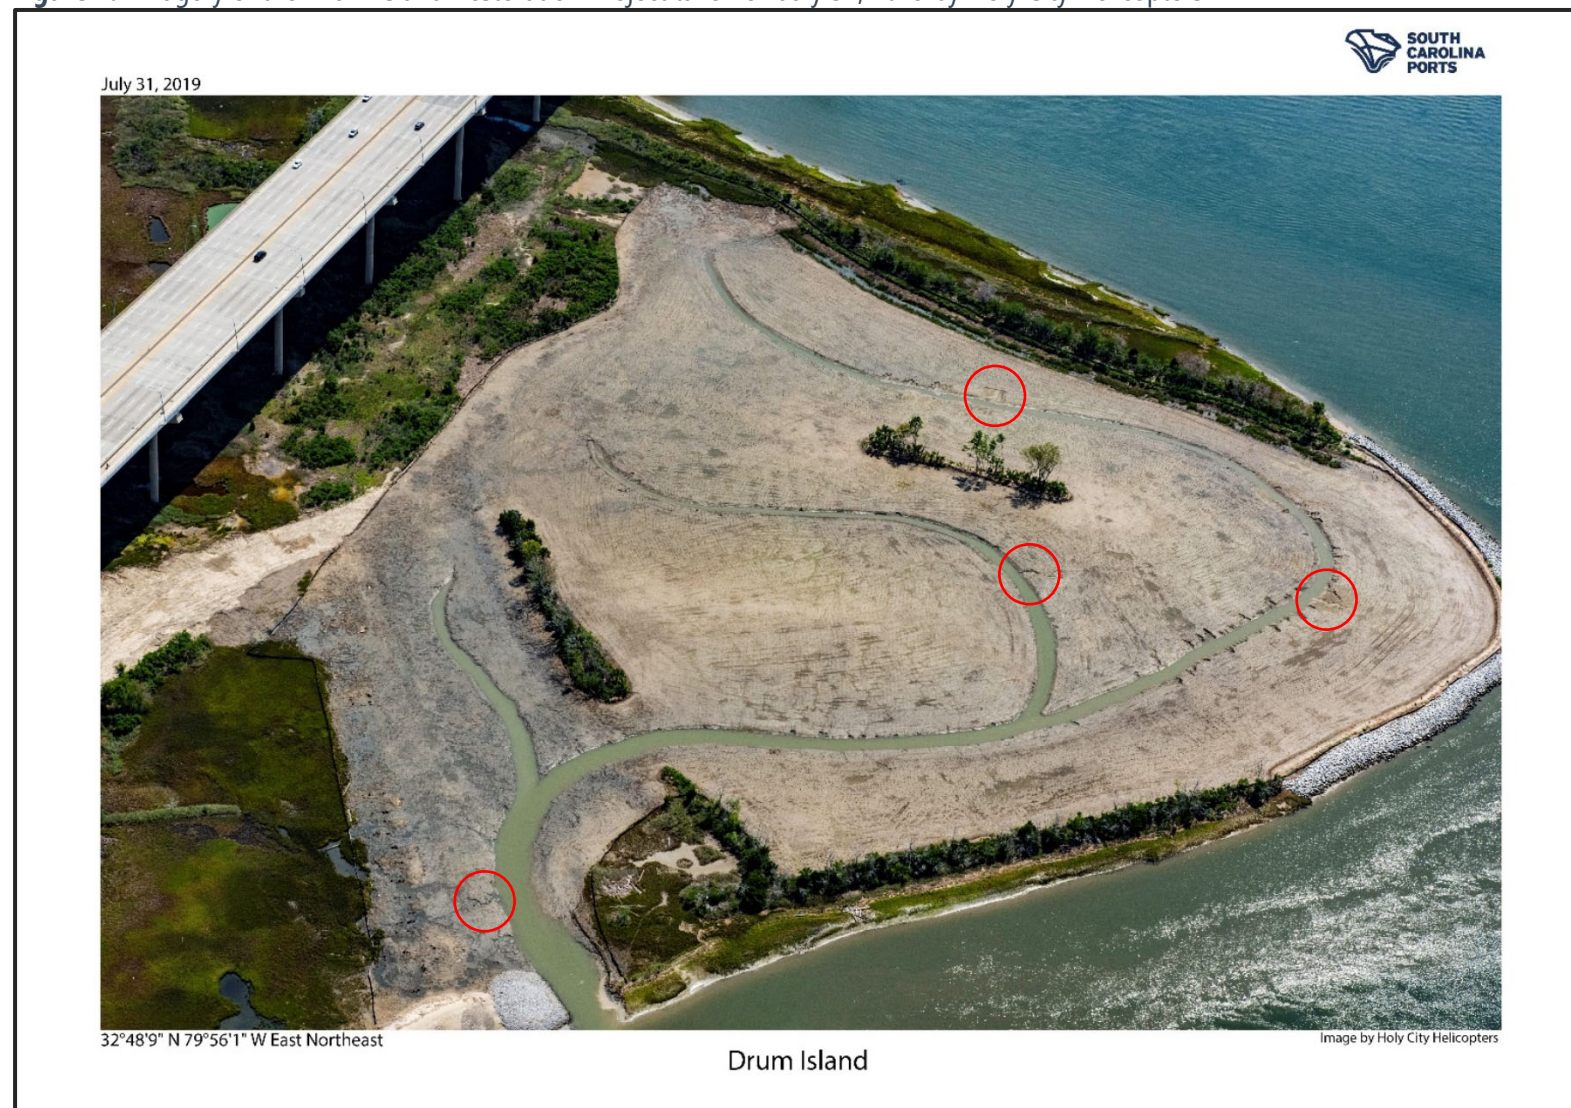
**Figure 1:** Imagery of the Drum Island Restoration Project taken on July 31, 2019 by Holy City Helicopters

During post-construction field visits tidal creeks were observed and noted as stable. First-order tidal streams appear to be naturally forming adjacent to the constructed channel. Complexity of the tidal channel network appears to be increasing over baseline conditions. Figure 1 below is a depiction of potentially newly forming tidal creeks adjacent to the main channel.

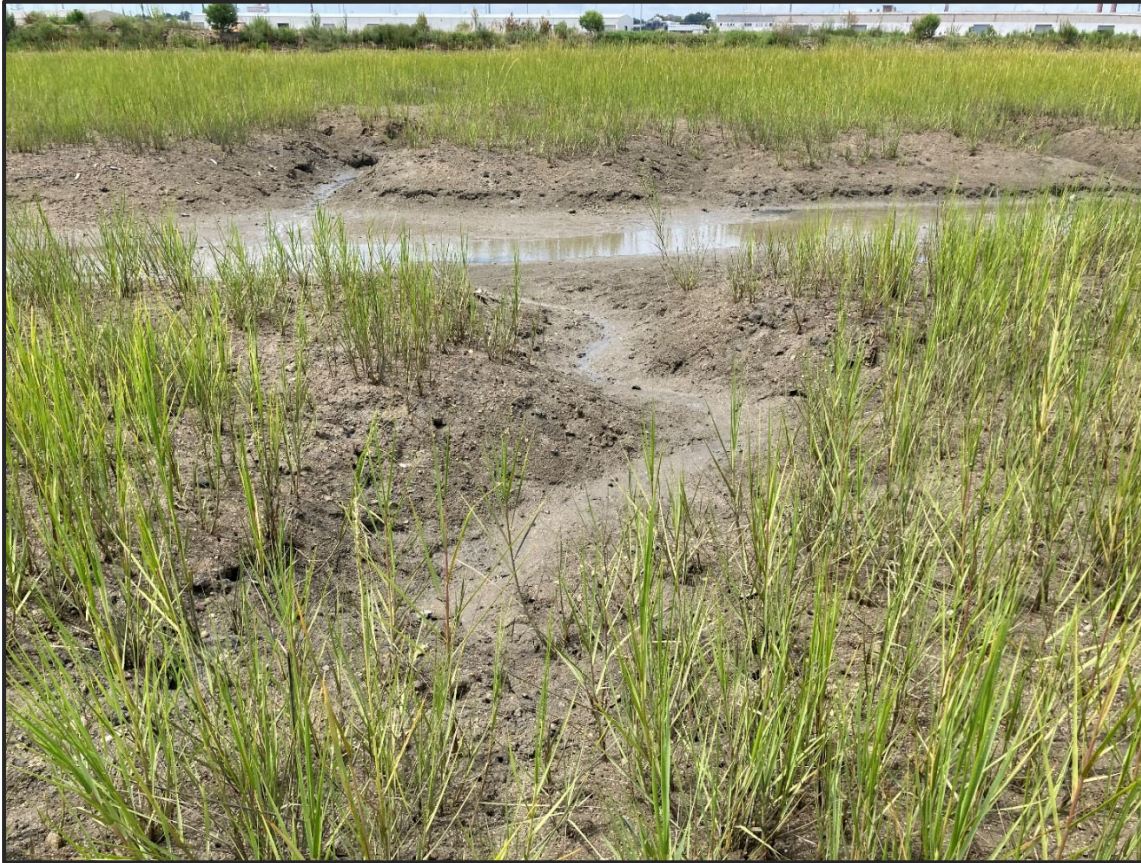
**Figure 2:** Beginning stages of a small tidal stream naturally forming adjacent to the main channel

Figure 2 below is a photograph of the initial stage of a small tidal drainage system forming due to natural sedimentation. During various field visits throughout the post-construction monitoring period, minute surface drainage patterns within the intertidal zone appear to be becoming more pronounced and exhibit morphology typical of a tidal channel. General site photographs of the tidal creeks are included in Appendix B.

The tidal creeks observed appeared to be a natural conduit for the tidal waters to enter the restoration area with flooding and ebbing with the natural tidal cycles evident. A variety of organisms have begun to colonize the intertidal zone that were not observed during pre-construction or during baseline monitoring including: mud fiddler crabs (*Uca pugnax*), sand fiddlers (*Uca minax*), blue crabs (*Callinectes sapidus*), shrimp and small fish were also noted as present in the main channel.

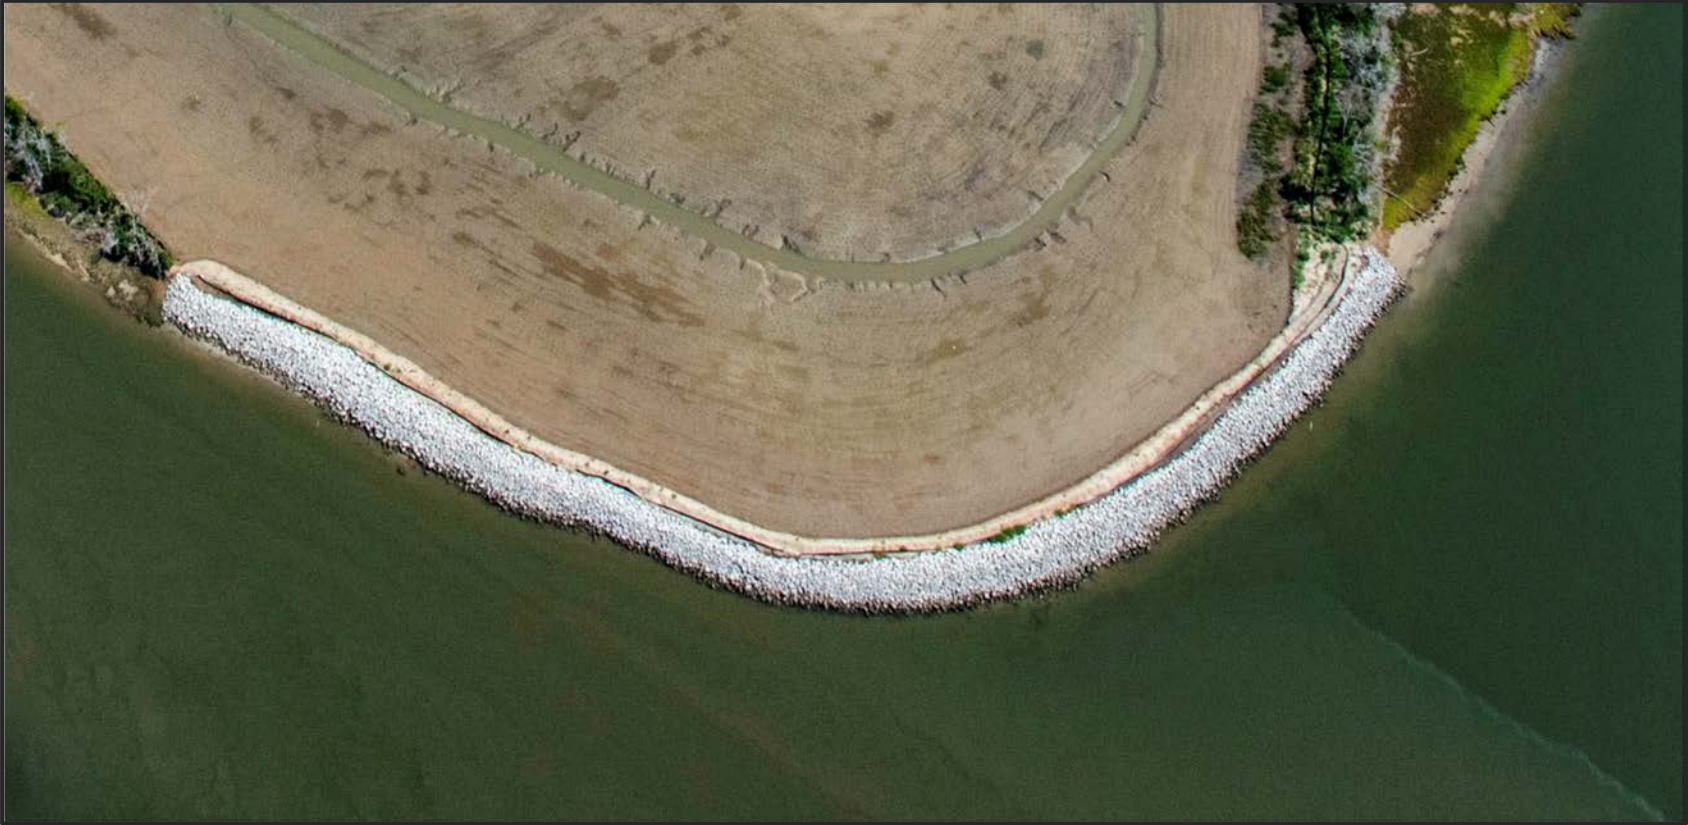
**Figure 3:** Aerial View of the revetment along the southern end of Drum Island

The riprap revetment appears to be stabilized with no visible signs of erosion.

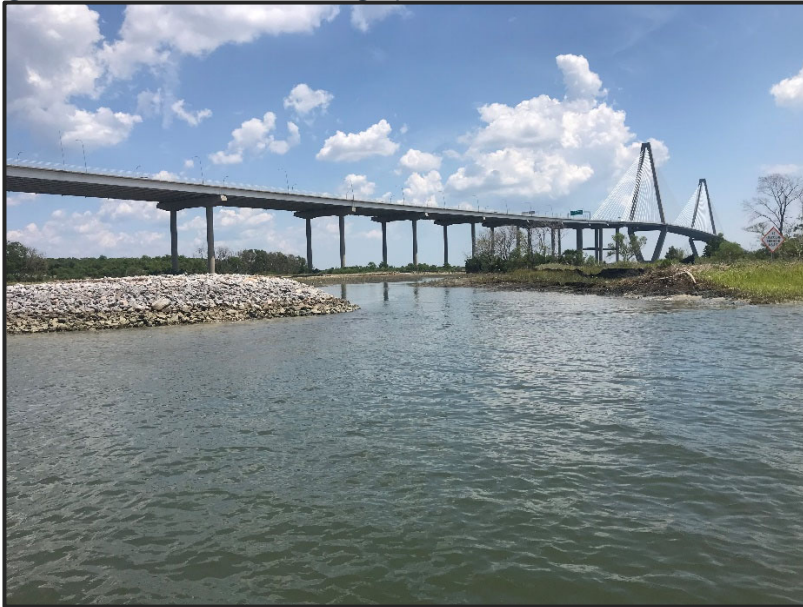
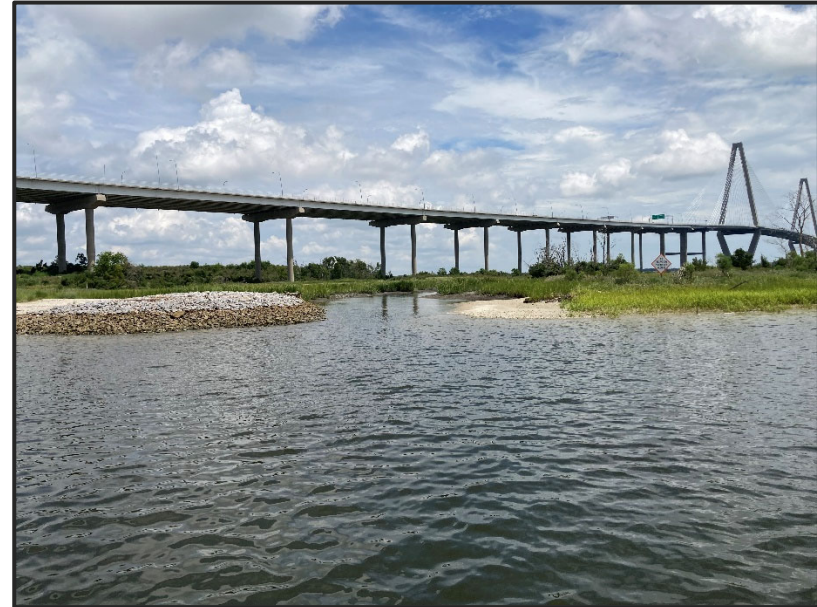
**Figure 4:** Tidal Creek Inlet Photographs 2019-2020

No visible changes regarding the stability or integrity of the riprap adjacent to the mouth of the tidal creek was observed during the most recent monitoring event. The riprap appears to be stabilized with no visible signs of erosion.

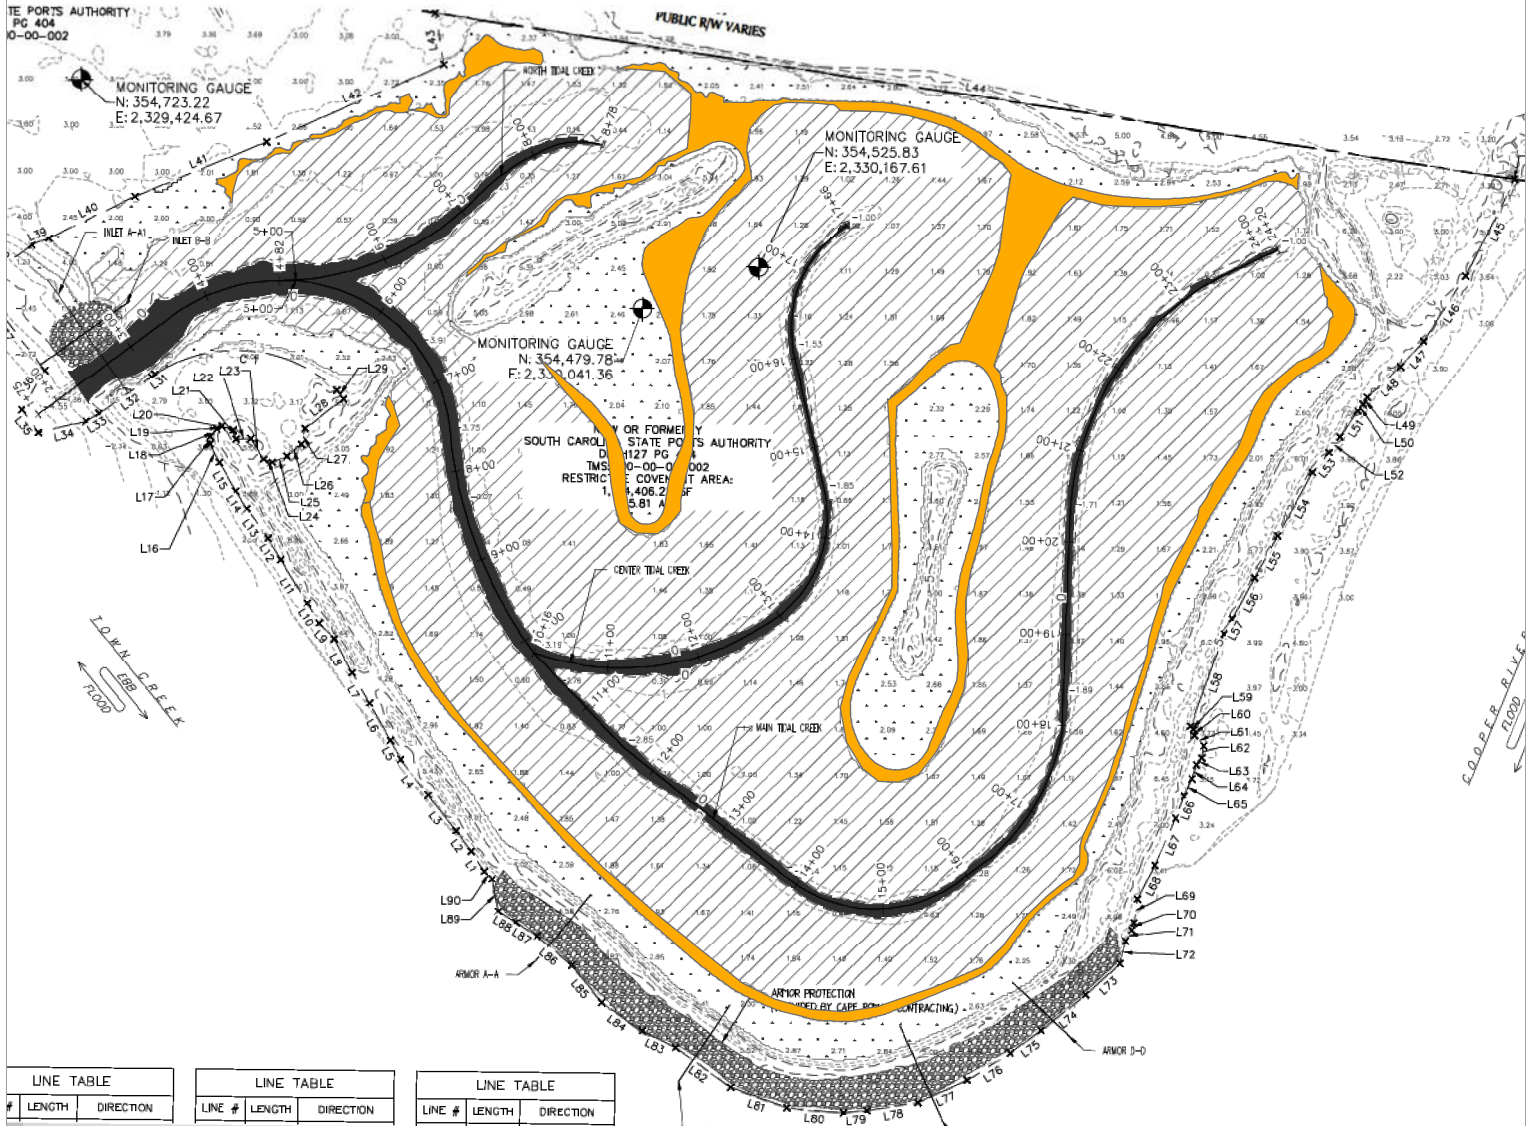
Figure 4 - Estimated Conversion Map

Estimate of Probable High Marsh Conversion to Low Marsh (1.5 AC)
