October 9, 2020

RE: Year 1 Post-Construction Monitoring Report  
Drum Island Marsh Restoration  
Charleston County, South Carolina  
JMT Project Number: 18-03770-001

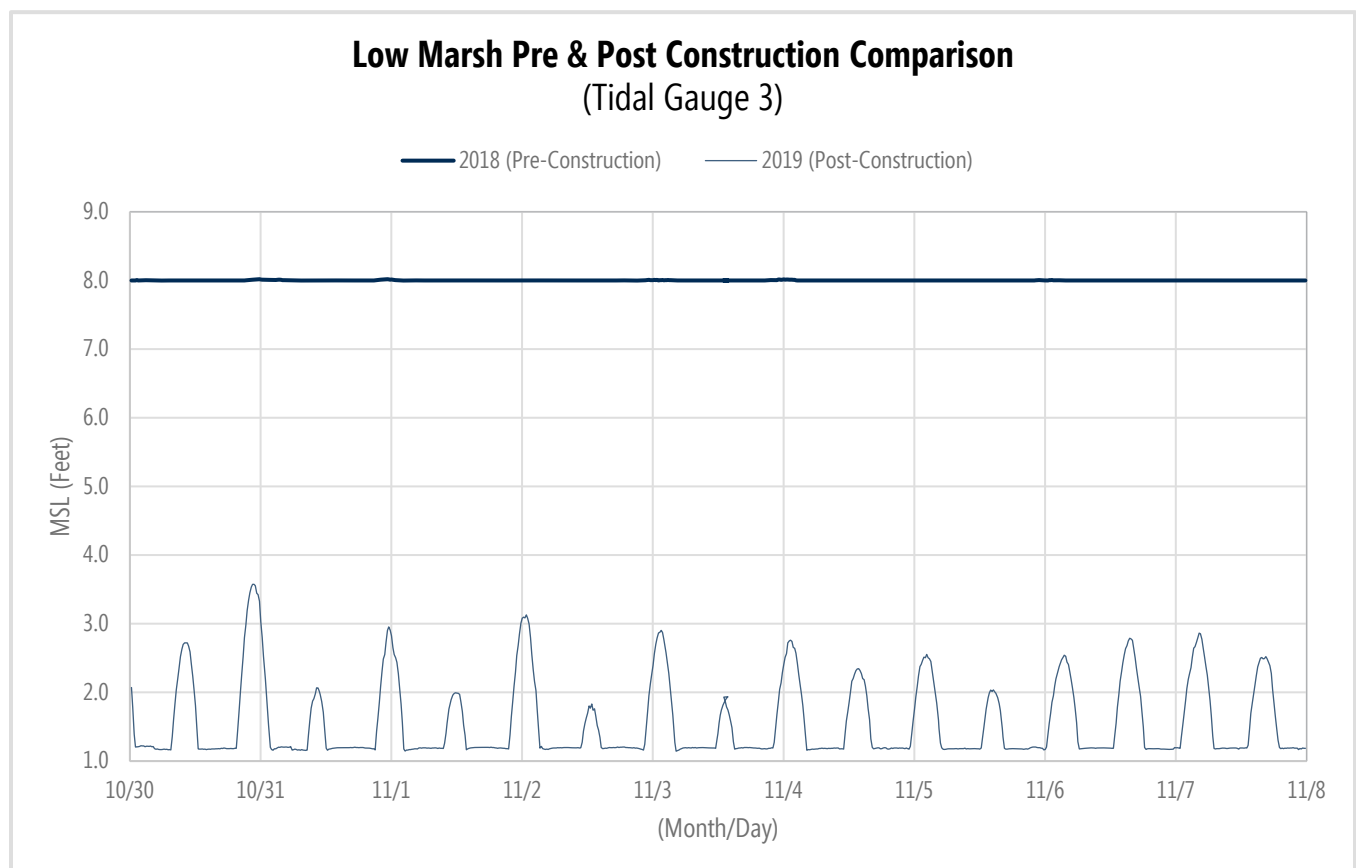
**Chart 1:** Pre-Construction and Post-Construction Water Level Comparison for Low Marsh Restoration

Pre-construction hydrology data for Tidal Gauge 3 (Low Marsh Restoration), suggest that these areas experienced little or no tidal influence prior to construction, with water levels less than 0.2 feet reaching the ground surface only for brief periods of time. Tidal influence is evident throughout the post-construction period at Tidal Gauge 3.

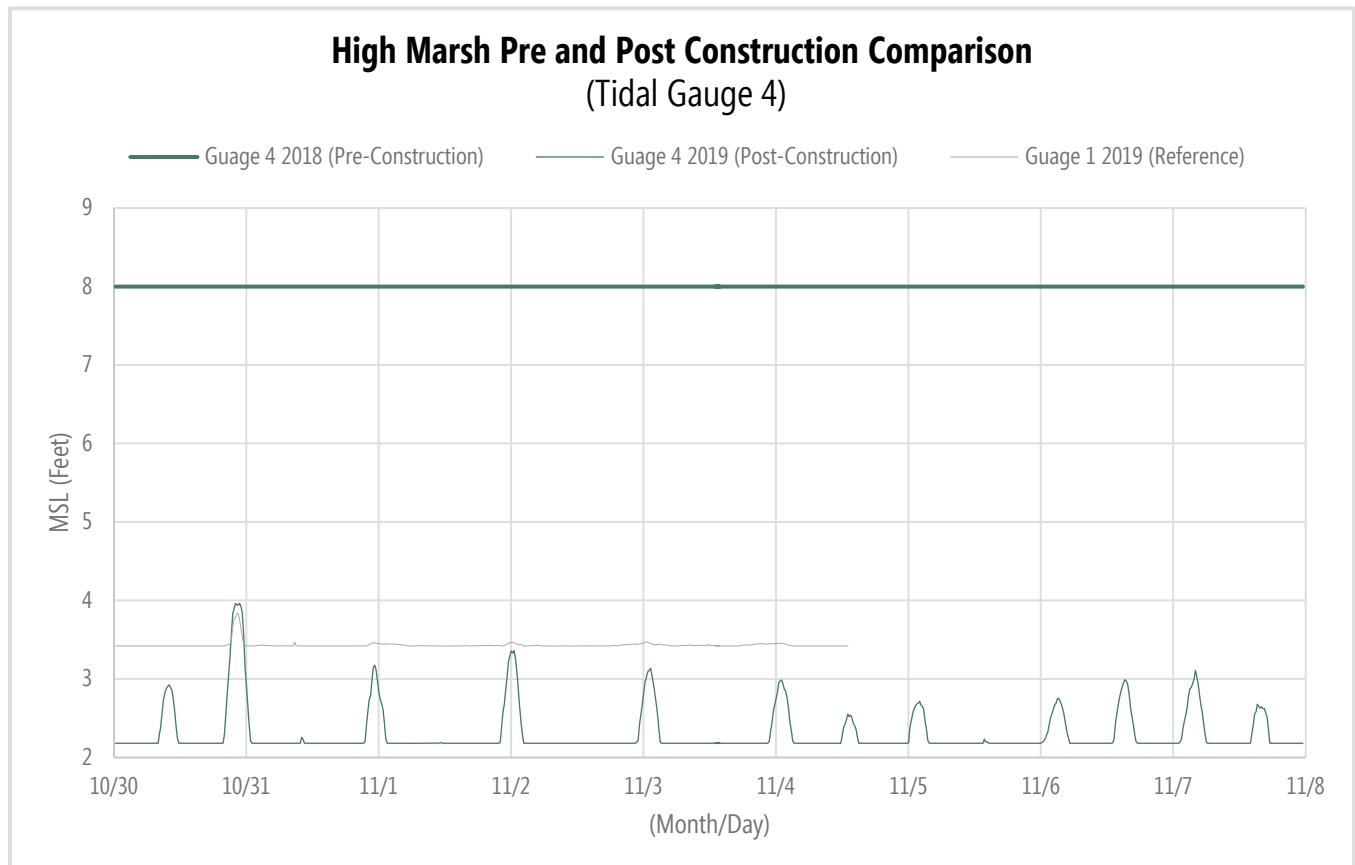
**Chart 2:** Pre-Construction and Post-Construction Water Level Comparison for High Marsh Restoration

Pre-construction hydrology data for Tidal Gauge 4 (High Marsh Restoration), shown in Chart 2 above, suggest that these areas experienced no tidal influence prior to construction. Post construction monitoring activities for Tidal Gauge 4 indicate that tidal influence is evident throughout the post-construction period and is comparable to Reference Conditions (Tidal Gauge 1).

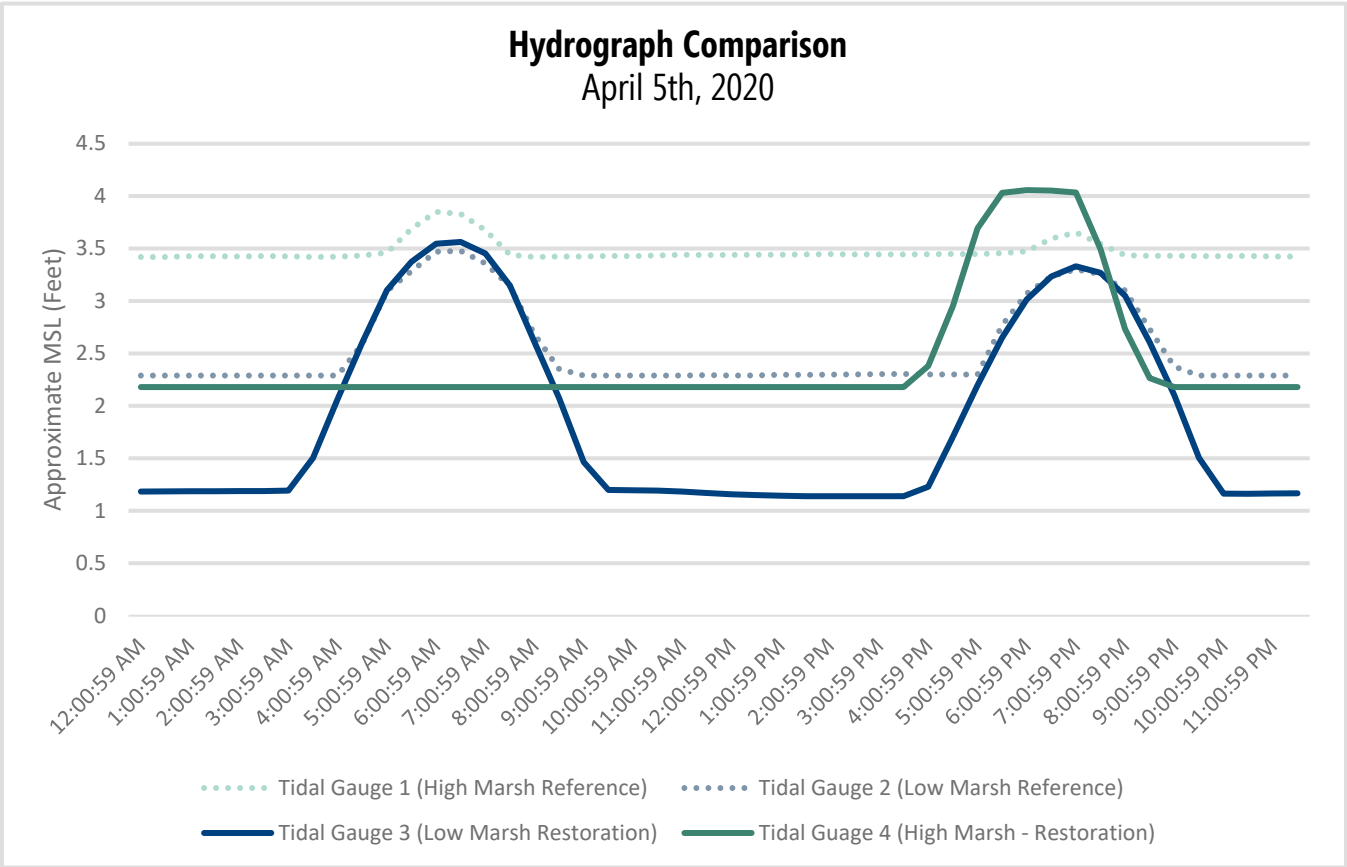
**Chart 3:** Representative Tidal Cycle on April 5<sup>th</sup>, 2020

Tidal movement appears to be functioning properly for Gauges 1, 2, and 3. Gauge 4, located in the high marsh restoration area, did not show tidal influence during the first tide, but shows tidal influence earlier than the surrounding gauges for the second tide. This is likely attributed to gauge malfunction that resulted in slightly incorrect readings. The gauge began reading abnormally incorrect values shortly after, on May 4<sup>th</sup>, 2020. The gauge was sent off for maintenance and replaced. Due to the abnormality observed in Chart 3 above, Chart 4 below was created to show tidal fluctuation on July 11<sup>th</sup>, 2020 to ensure tidal lag is not occurring.

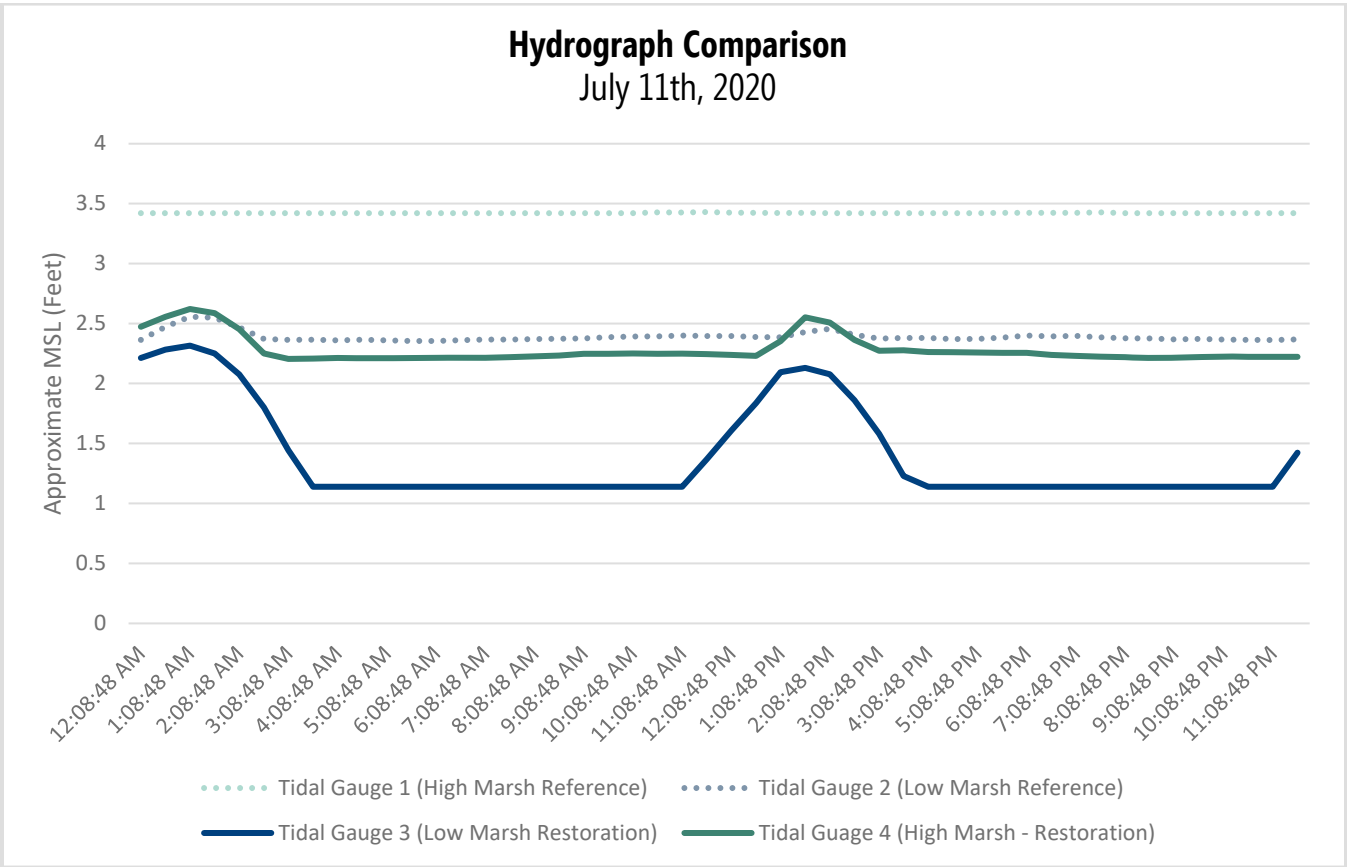
**Chart 4:** Representative Tidal Cycle on July 11th, 2020

Tidal movement appears to be functioning properly throughout the restoration areas and tidal fluctuations are experienced during the same time periods. Tidal flushing has been successfully introduced. Post construction trends will continue to be monitored in subsequent monitoring events to document whether tidal flows are increasing or decreasing over time and/or whether subsidence is occurring on the project site.

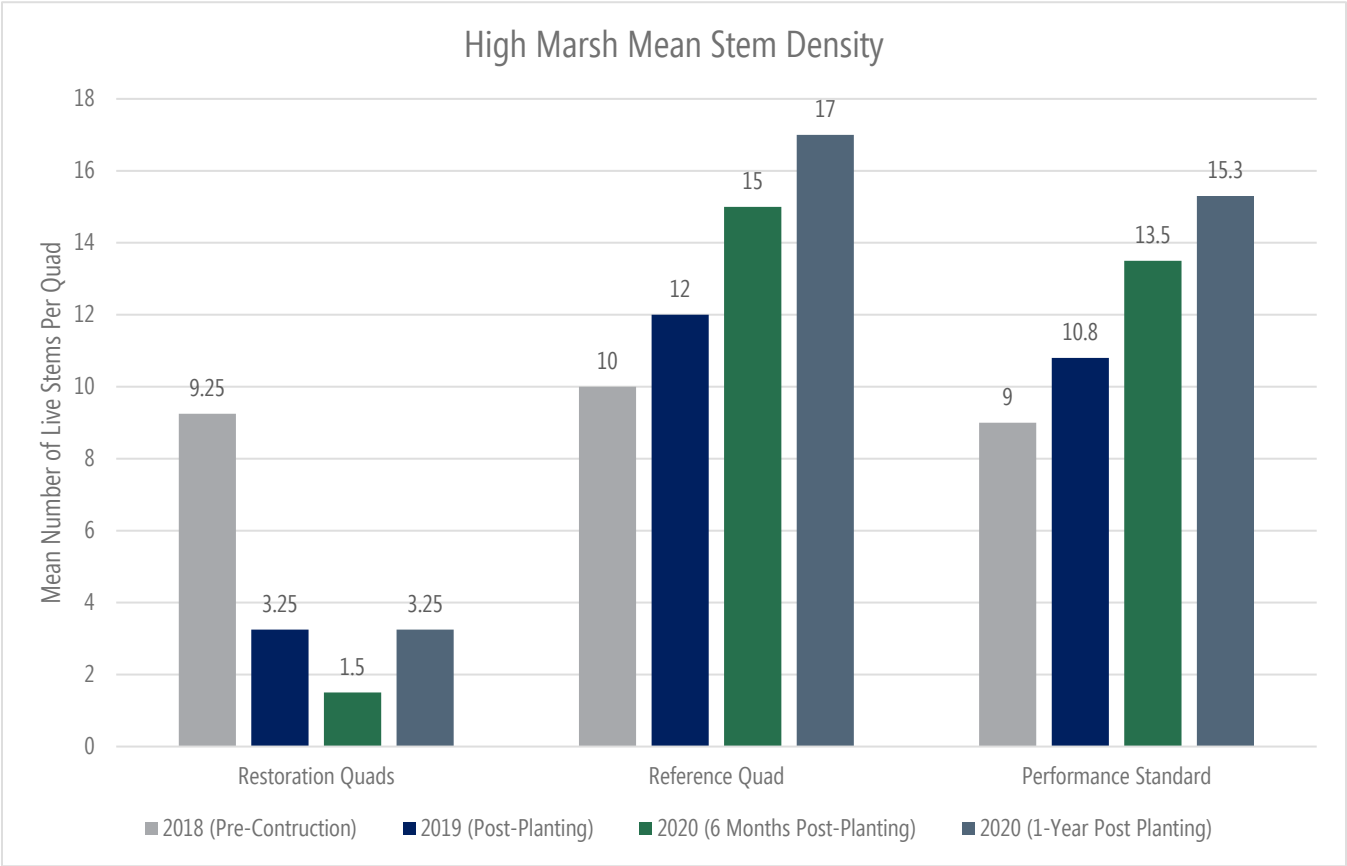
Chart 5: Average Stem Density for High Marsh Quadrats

Stem counts for the high marsh reference (Ref Quadrat #1) have ranged from 10 – 17 stems over the monitoring period. The noticeable increase in stem counts for reference conditions is attributed to the limited scale of the y-axis display, and minor variations in quadrat placement. This increasing trend is likely not indicative of increasing density for reference conditions.

High marsh restoration quadrats had an average density of approximately 3 stems per quad during the most recent monitoring event. Vegetation quadrat stem count data suggests some planted high marsh species have thrived, while other species have not survived and suitable volunteer species have begun to naturally regenerate. Perennial glasswort (*Salicornia virginica*) has shown propagation over baseline, while black needle rush (*Juncus roemerianus*) has remained visibly stressed at Quadrat #1 and did not survive in the remaining sampled Quadrats. Sea oxeye daisy (*Borrichia frutescens*) did not survive at Quadrat #2 and shows improvement at Quadrat #5. Saltmarsh cordgrass (*Spartina alterniflora*) propagation is evident at Quadrat #4 and field observations indicate *Spartina* along with other suitable species are naturally regenerating throughout the majority of the high marsh restoration areas.

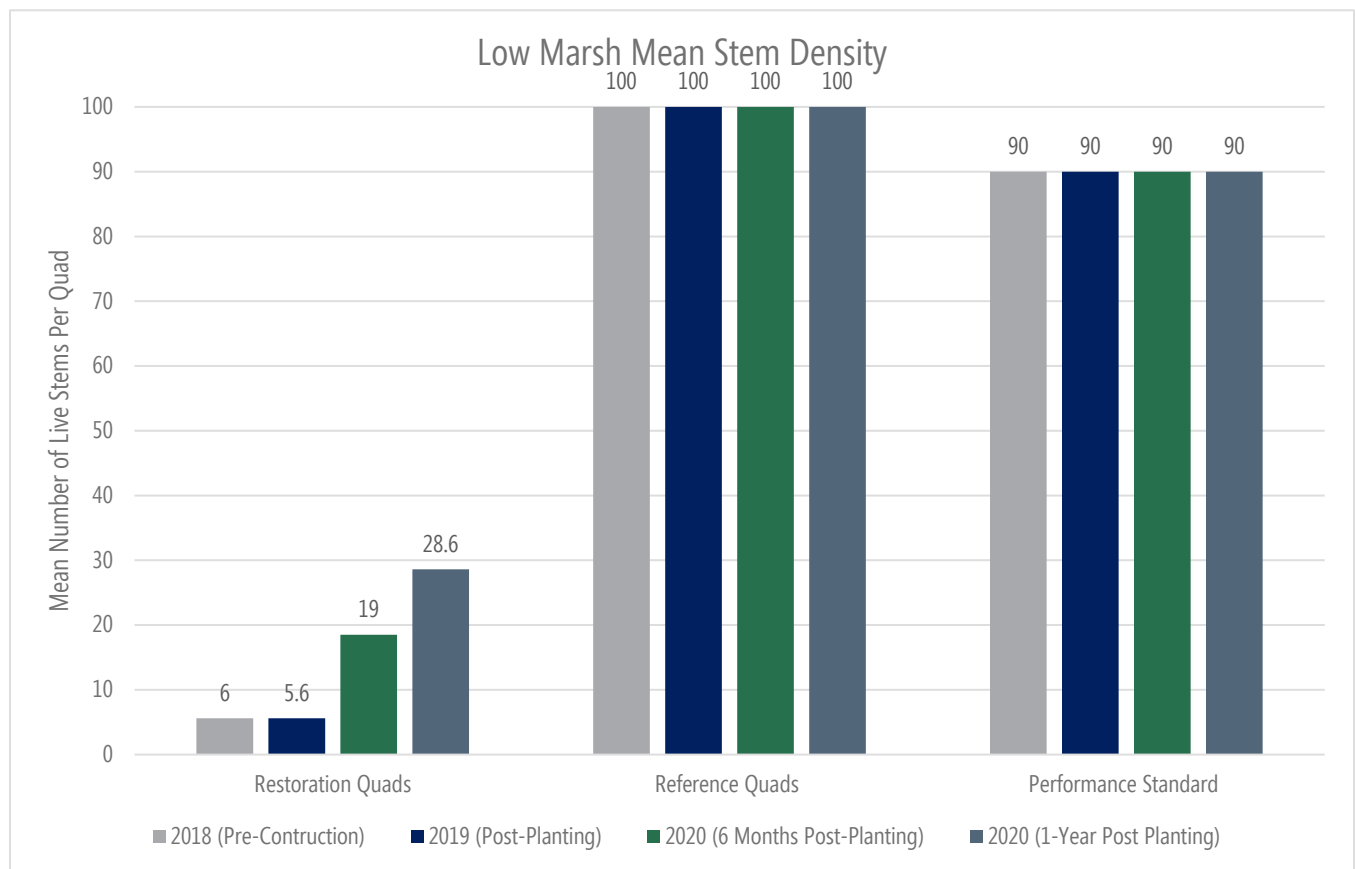
**Chart 6: Average Stem Density for Low Marsh Quadrats**

Low marsh quadrats had an average density of 29 stems during the most recent monitoring event. Stem counts increased by over 5 times the number of stems that were present during time-zero monitoring. Low Marsh Quadrats were dominated exclusively by saltmarsh cordgrass (*Spartina alterniflora*). Field observations indicated planted specimen in the reference areas appeared larger in height and width when compared to reference vegetative conditions. The *Spartina* are thriving and are expected to continue to disperse and show an increase in density in subsequent monitoring years.

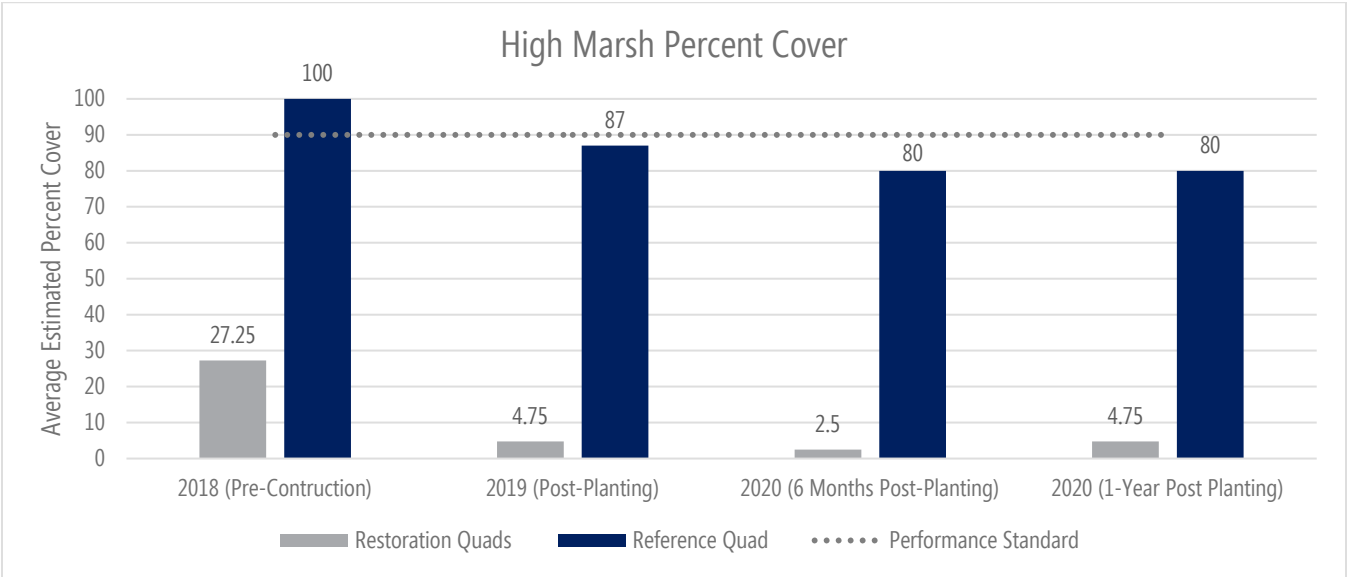
**Chart 7: Average Percent Cover for High Marsh Quadrats**

The average percent cover of restoration quadrats decreased from 2018 to 2019 due to removal of the existing vegetation and re-planting of the site with native sprigs. A minimal decrease in percent coverage in the 6-month period after planting is attributed to plant mortality that has occurred. During the most recent monitoring event (one-year post planting), the average percent cover has recovered to the same level (4.75%) noted during “time-zero” monitoring. Most of the high marsh vegetation that has survived is currently thriving and is expected to show an increase in percent coverage in subsequent monitoring events.

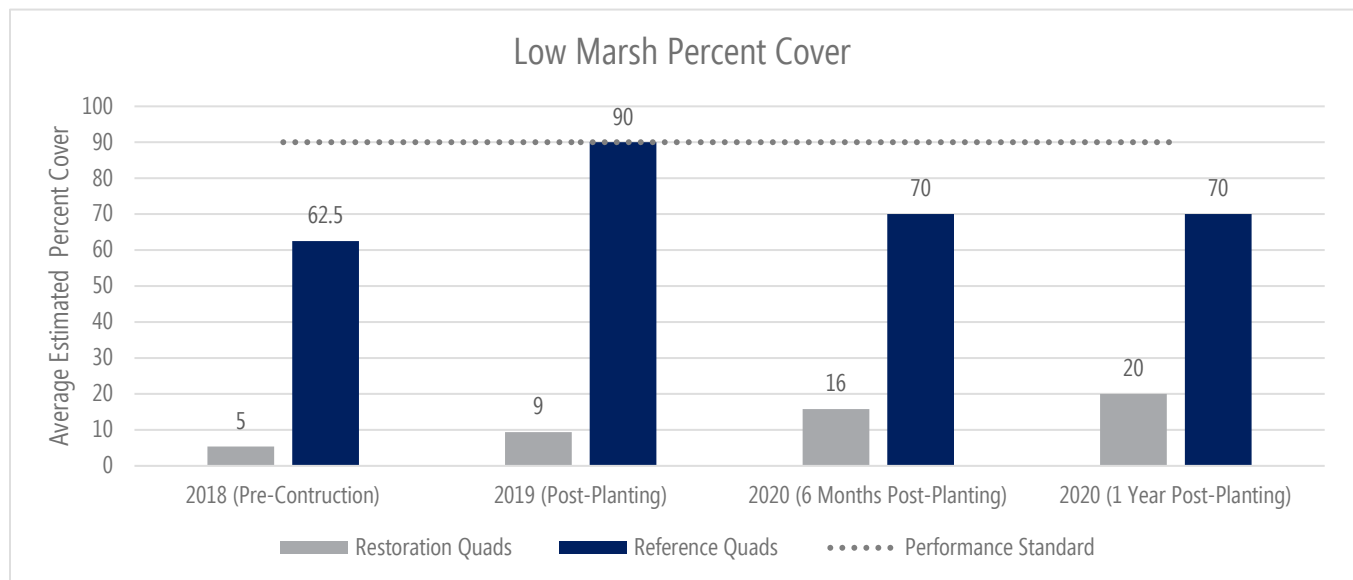
**Chart 8: Average Percent Cover for Low Marsh Quadrats**

Low marsh restoration quadrats had an average estimated percent coverage of 20% during the most recent monitoring event. The percent coverage has more than doubled since the time-zero monitoring event. Field observations indicate that planted sprigs have dispersed and growth throughout the low marsh areas is evident and is expected to continue to occur.

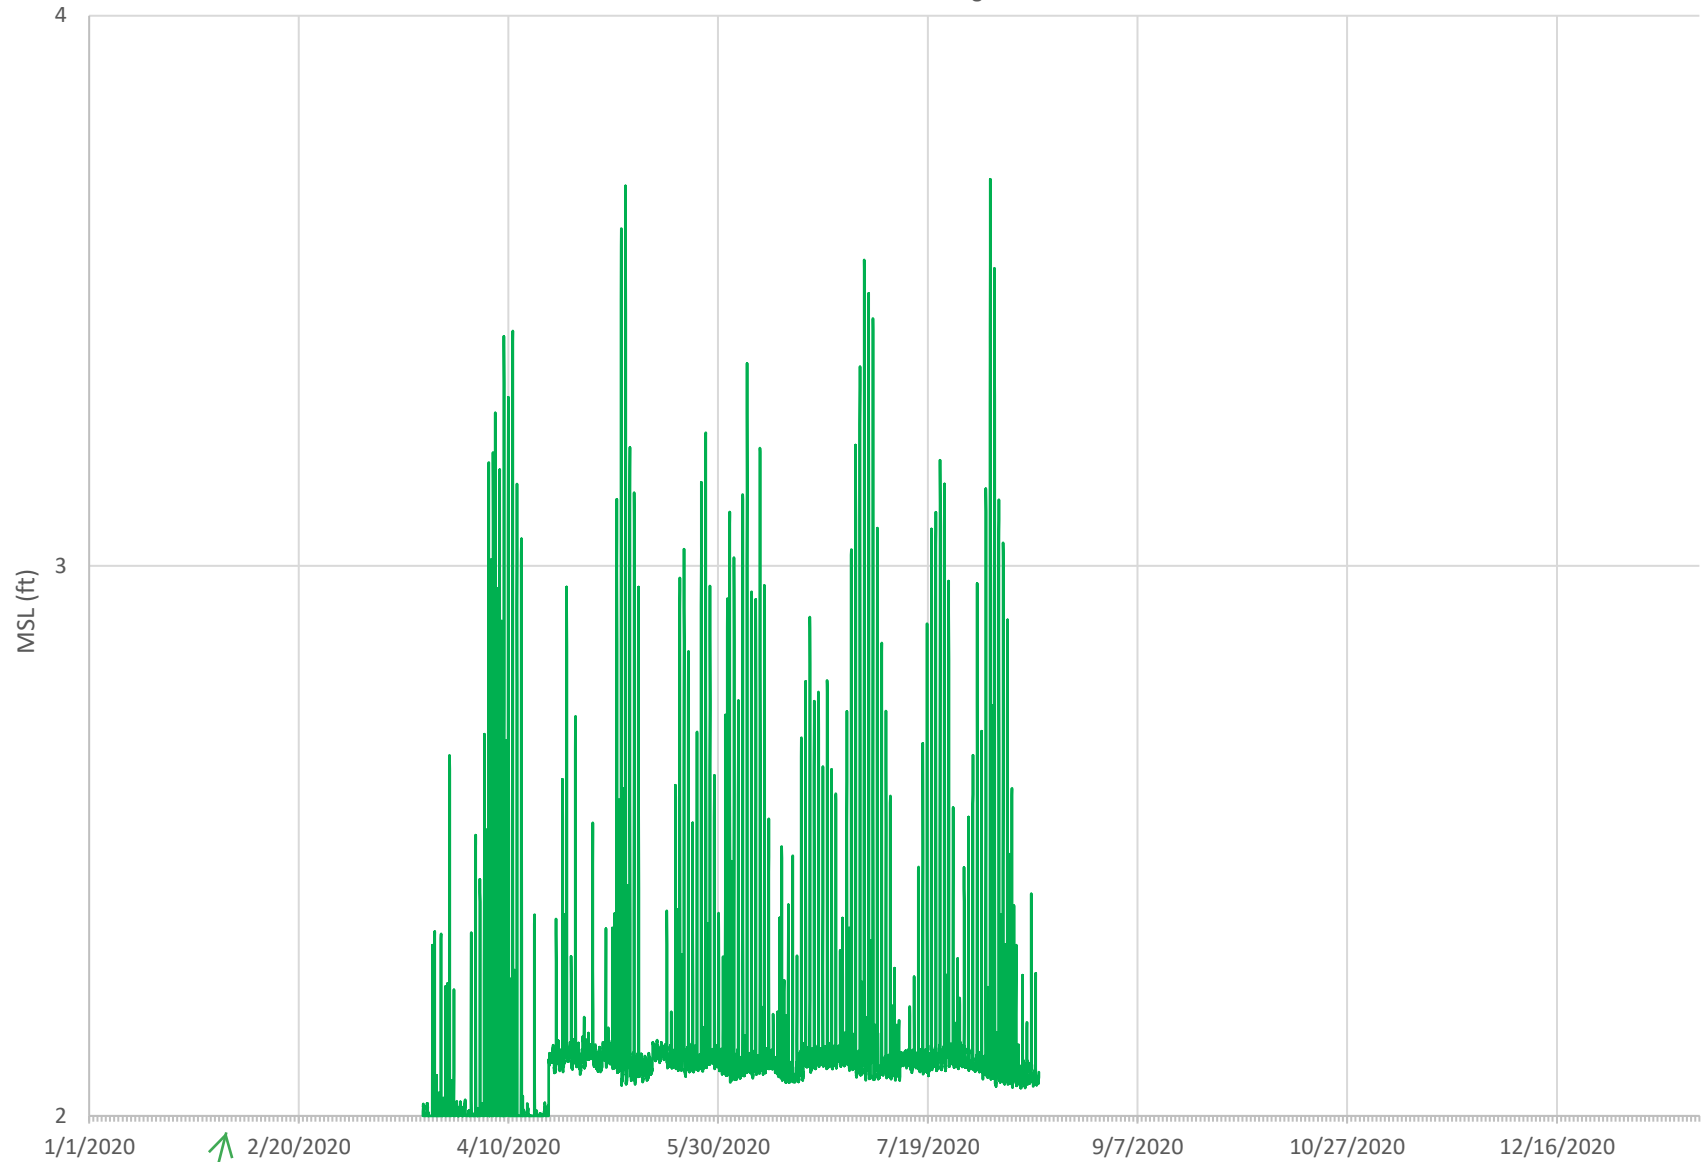
# Low Marsh Reference (Post-Construction - 2020)

Logger Failure

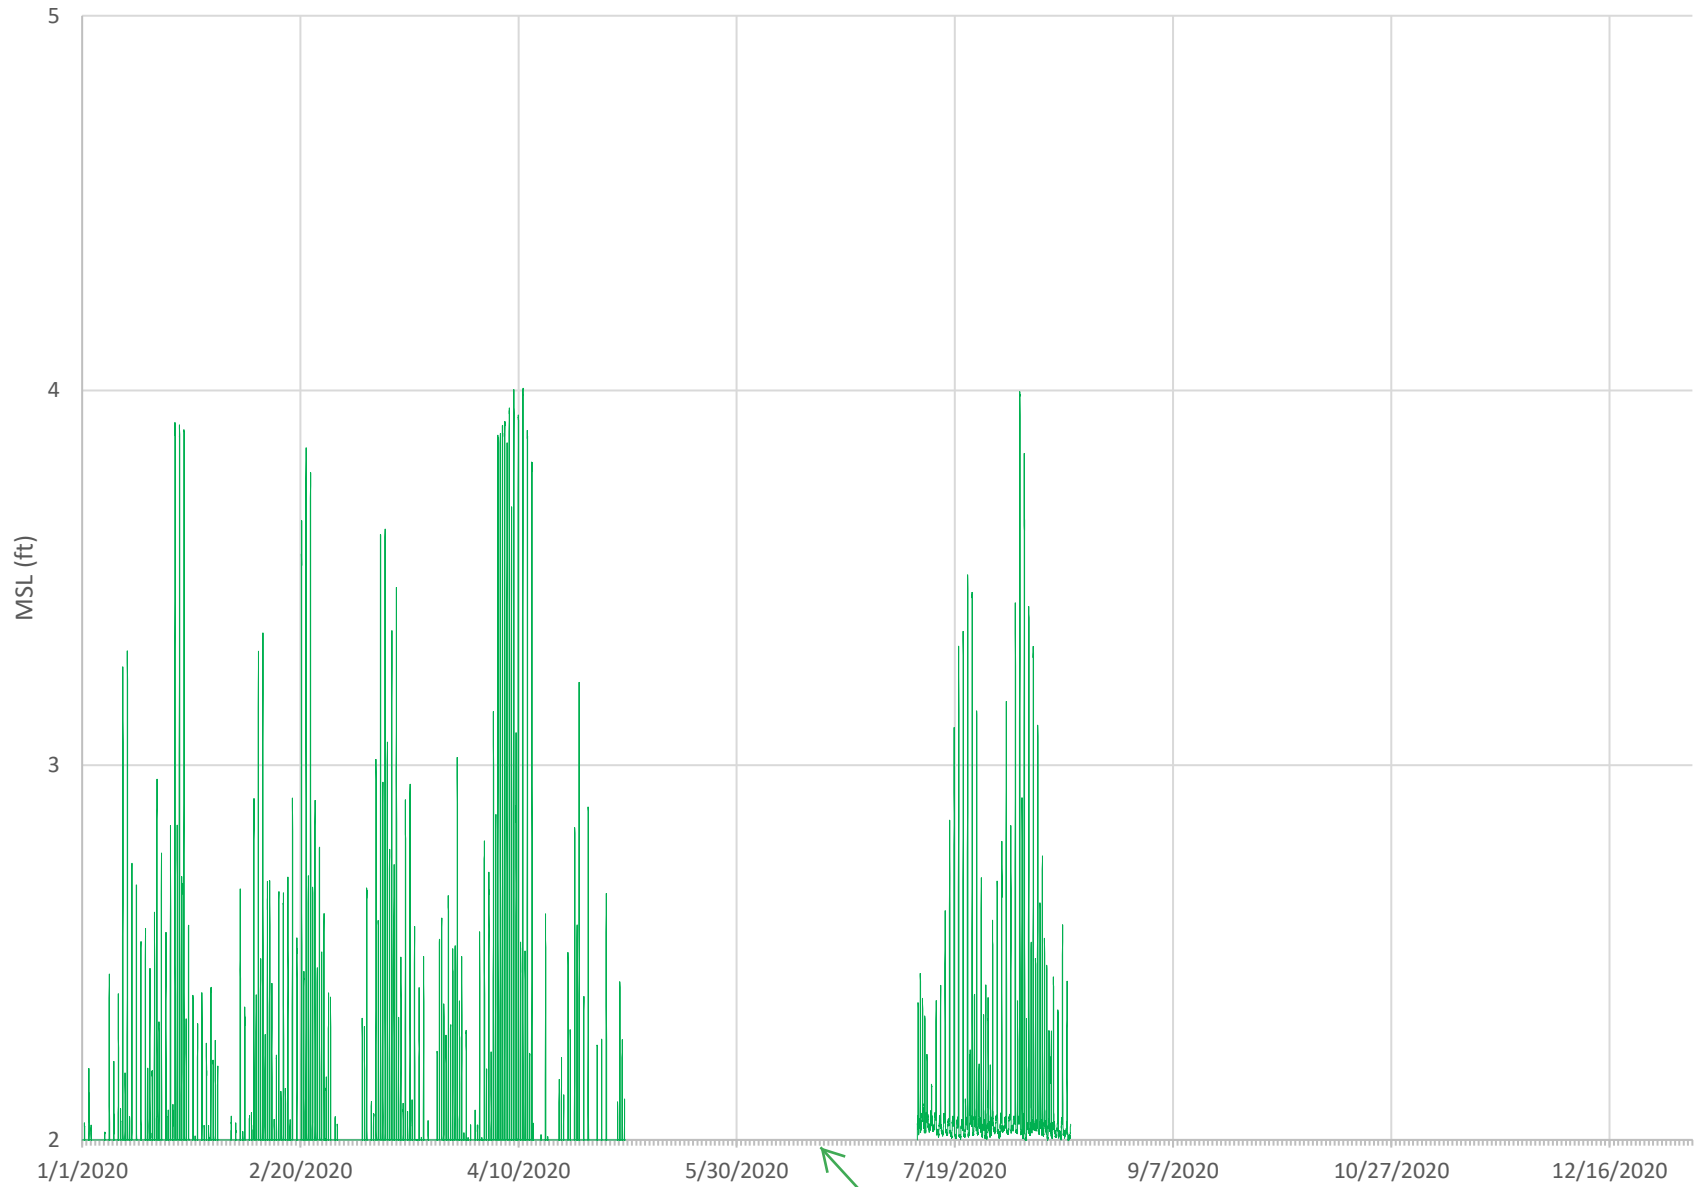
## High Marsh Restoration (Post-Construction -2020)

Logger Failure
